**UCI ENGINEERING, INC.**  
**CASTLE BEACH CLUB CONDO**  
**UCI Project No. 0407-121**  
**FIELD INSPECTION REPORT No. 2**

To:	Mr. Leo Gonzalez	Report Date:	November 16 <sup>th</sup> , 2004
From:	Oscar Castells	Visit Date:	November 5 <sup>th</sup> , 2004
Project:	CASTLE BEACH CLUB CONDO	Address:	5445 Collins Avenue
Proj. No:	0407-121		Miami Beach, Florida
Ref:	RECOMMENDATIONS REGARDING EXISTING BUSDUCTS, SWITCHGEAR AND MOTOR CONTROL CENTERS

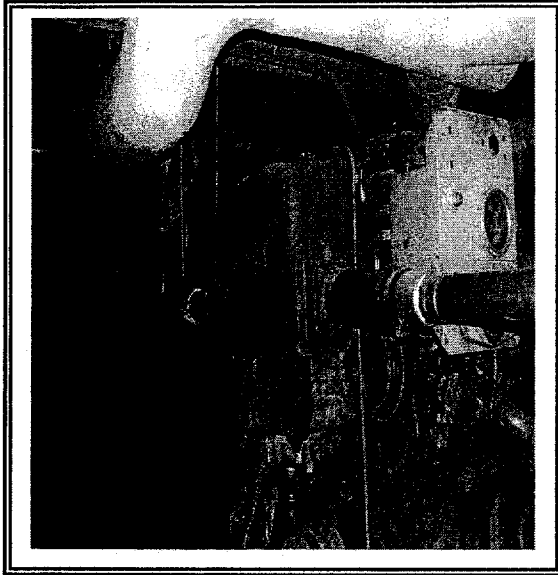
- 1) The emergency generator room is located in a poorly ventilated room in the basement garage level.
- 2) The emergency generator cooling system consists in a direct connection to a water main pipe, with no apparent water recirculation.
- 3) There is no Automatic Transfer Switch (ATS) to automatically detect a power outage, start the generator engine and reconnect to emergency service the required life safety loads.

Photo No. 9  
Generator Cooling Water Connection

- 1) Perform a load bank test of the generator to evaluate its present condition, including the sufficiency of its existing ventilation and cooling systems.
- 2) Provide any improvement that may be required as a result of the generator load bank test.
- 3) Provide an adequate ATS to automatically detect power outages, start the generator engine and transfer the life safety loads from normal to emergency power.

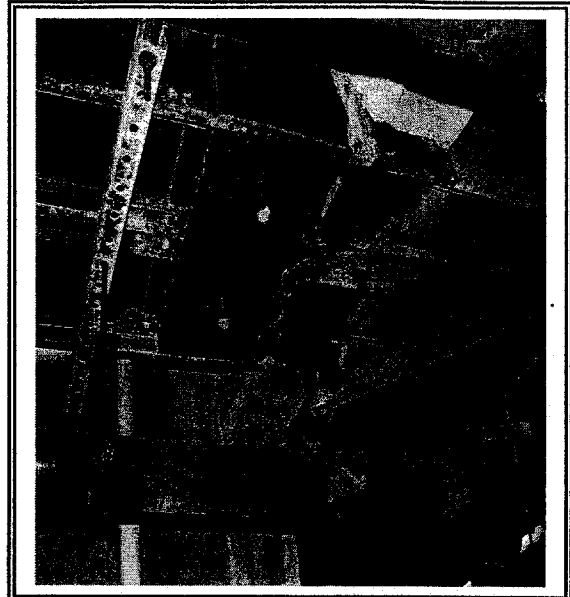
Photo No. 6  
See rust and against code installation

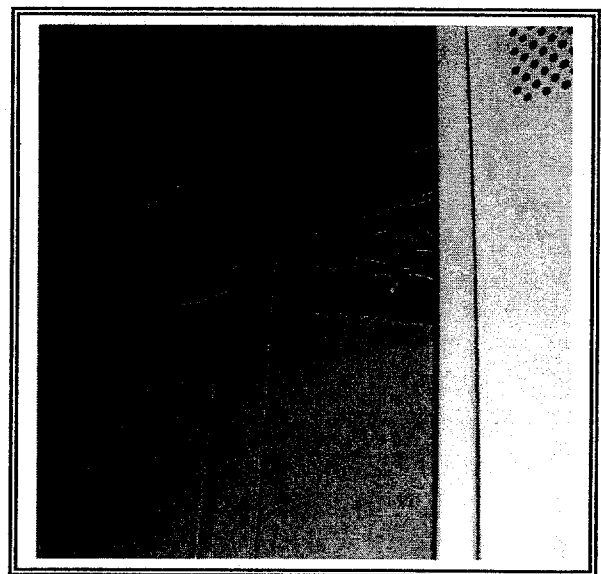
- 1) There are three old MCC in the electromechanical area in the lower lobby level are. Two of them installed back to back have several cubicles abandoned, and a few cubicles in use but without cover and with wires exposed.
- 2) The double MCC has no housekeeping pad and is located nearby to the fire pump and other water pumps. It is evident that water spillages from the pumps have reached the area of the MCC rusting the lower part of the cabinets and probably leaking down to the lower level through the electrical conduits penetrating through the slab.

Photo No. 8  
Covers required

- 1) To provide new MCC's to replace the existing old ones.
- 2) To provide 4" high housekeeping pads for each new MCC.
- 3) To provide a low cement bump to contain water spillages from the fire pump and prevent it to reach the MCC area.

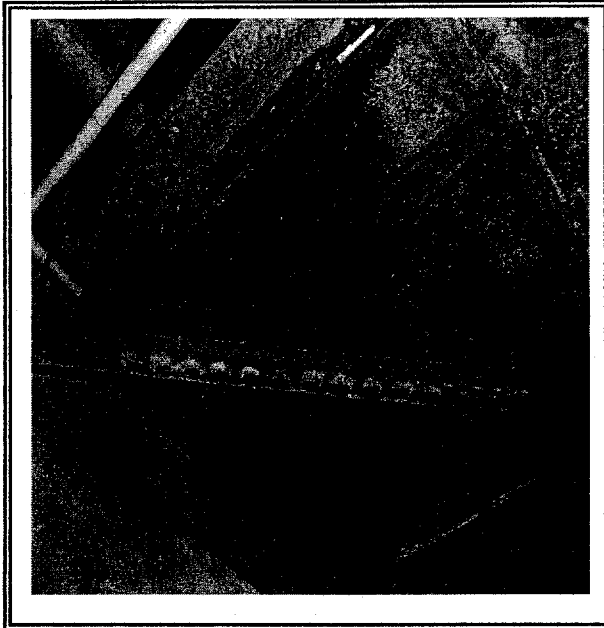
Photo No. 1: Main Switchgear Room  
See rust
